MANCHAUG POND DAM

MA. 00955

PHASE I INSPECTION REPORT
NATIONAL DAM INSPECTION PROGRAM

JULY 1980

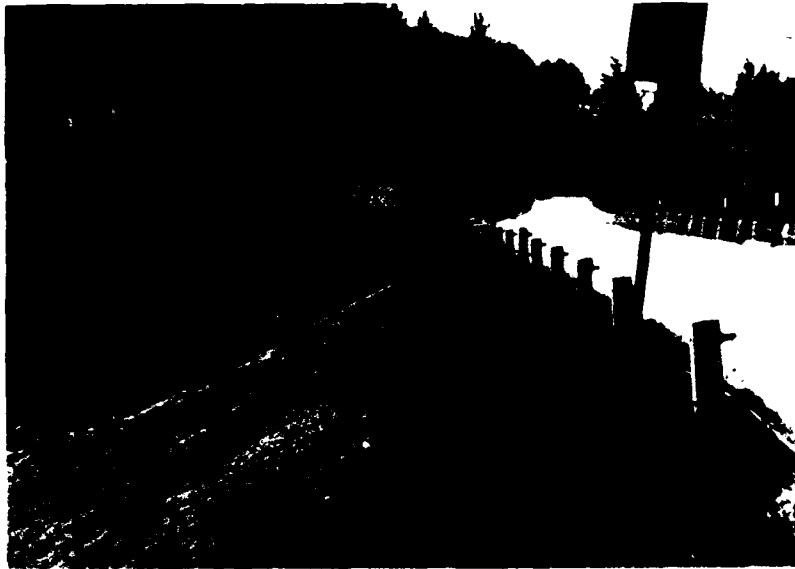
3. Downstream slope from left abutment

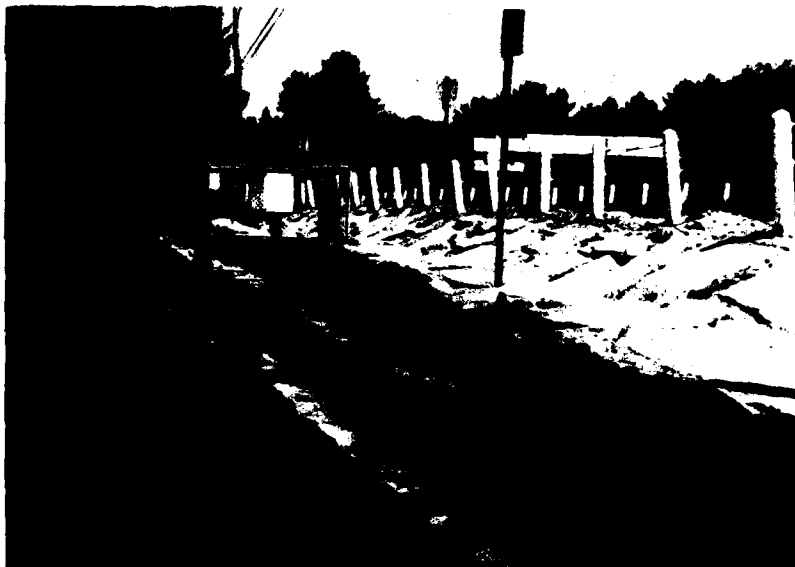
1. Upstream rubble masonry wall

(1) Repair minor spalling of the mortared joints of the upstream masonry rubble wall by repointing with mortar.
